CENTRAL INTELLIGENCE AGENCY

SUBJECT 1. 11th Fighter Aircraft Regiment
at Debrzno
2. MIG-15 Bis Aircraft

11th Fighter Aircraft Regiment

The MIG-15 Bis Aircraft

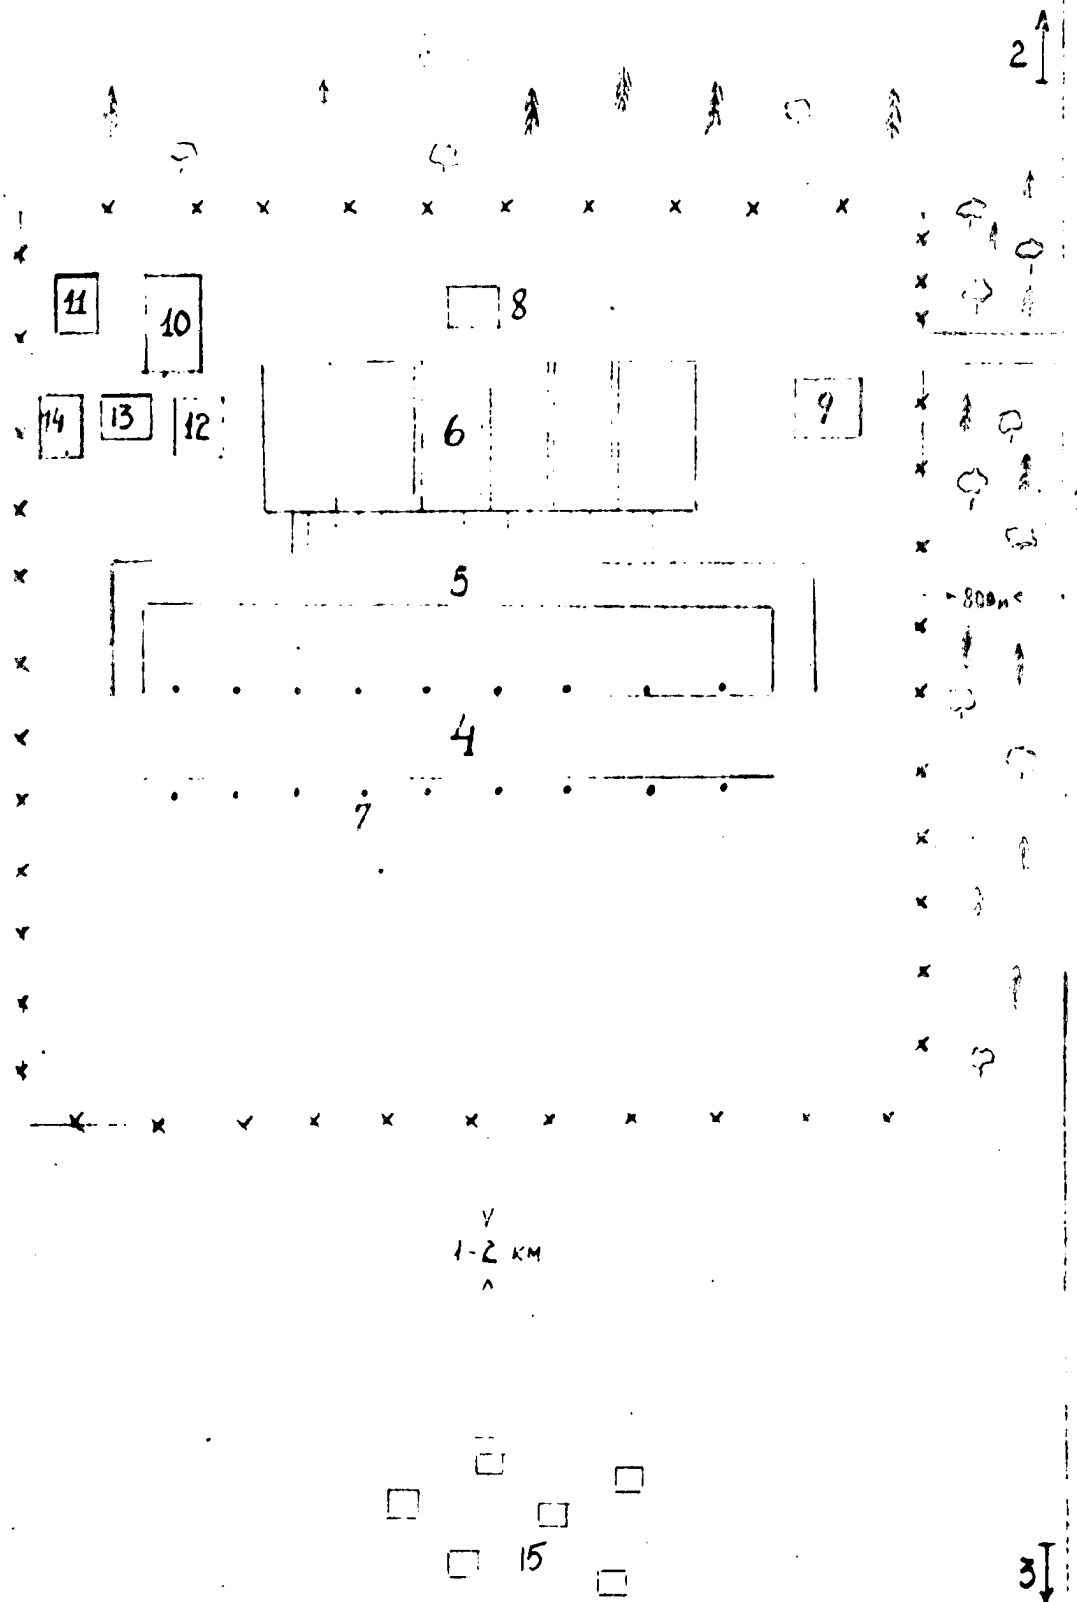
Legend to sketch

9. a sketch of the Debrzno airfield. The legend for the sketch is as follows:

1. Lipka Krajska-Debrzno Road
2. To Lipka Krajska
3. To Debrzno
4. Main runway
5. Taxi strip
6. Parking spaces
7. Red lights
8. Control tower
9. Fuel and lubricants (underground)
10. Barracks
11. Dining hall
12. Movie theater and club house
13. Showers and laundry
14. Clothing and technical equipment
15. Small village.

by barbed wire two meters high and is surrounded on three sides by trees; a small village can be seen from the open fourth side. The runway is approximately two kilometers long and 25 meters wide and is oriented at a right angle to the Debrzno-Lipka Krajenska road. A taxi strip, approximately 15 meters wide, parallels the runway, and the hard stands (Stojanka), each of which can hold two or three aircraft, are connected to the taxi strip by concrete strips approximately 10 meters wide. The two-story control tower is located near the hard stands.

The field also has a "take-off hut" (Buda Startowa) and a vehicle equipped with radio apparatus for ground-to-ground and ground-to-air communications. Red lights are installed on both sides of the runway for night flying, and three searchlight-equipped vehicles are used to illuminate the field at night. Fuel and lubricants are kept in underground facilities, and an ammunition dump is located in the field area. Three (?) radar stations are located in the vicinity of the field.
